EVALUATION OF CORROSION-RESISTANT REINFORCING STEEL

Research Summary

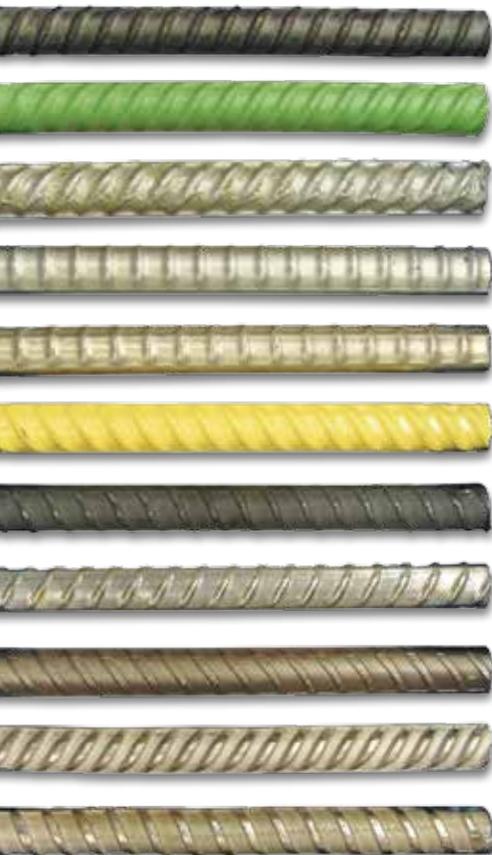
The Corrosion Study included the following reinforcing bars:

- Carbon-Steel (ASTM 615)
- Epoxy-Coated Steel (ASTM A775)
- Zinc-Coated (Galvanized) Steel (ASTM A767)
- Zinc-Clad (experimental)
- Tin-plated Zinc-Clad (experimental)
- Dual-Coated Steel (ASTM A1055)
- Low-Carbon, Chromium, Steel (ASTM A1035)
- Stainless-Steel 316LN (ASTM A955)
- Stainless-Steel 2205 (ASTM A955)
- Stainless-Steel 2304 (ASTM A955)
- Stainless-Steel XM-28 (ASTM A955)

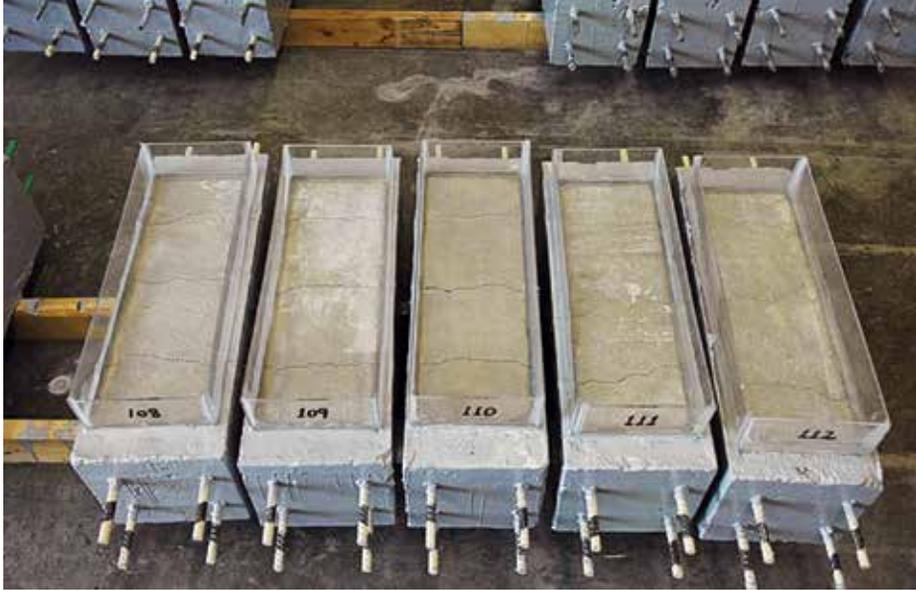
Cracked Concrete Macrocell Under Preparation For Corrosion Testing.

Cracks were obtained in the concrete specimens by applying tensile loads to the longitudinal bars. These cracks penetrated the thickness of the slabs. Target crack widths were 0.020 in., designed to represent field conditions with full-depth cracks. The obtained widths of cracks from all specimens ranged from 0.005 in. to 0.079 in. and 86% of the crack widths fell within the range of 0.015 in. to 0.035 in.

After cracks were introduced, the specimens were ponded using a 3% sodium chloride by weight salt solution. This solution was added following the ASTM G109 test procedure with a two week wet-cycle followed by a two week dry-cycle.

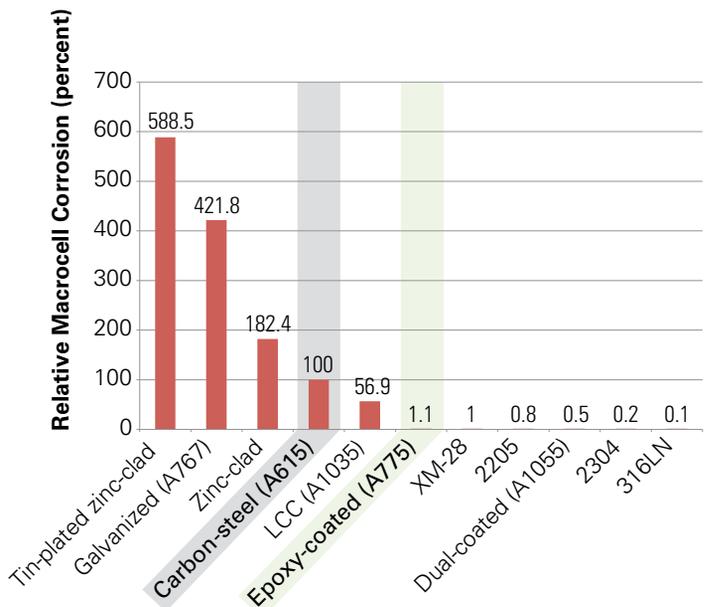
Figure 1: Relative Macrocell Corrosion.

Table 1: Macrocell Corrosion

Bar Type	Total Corrosion (coulomb)
Tin-plated zinc-clad	5573
Galvanized (A767)	3994
Zinc-clad	1727
Carbon-steel (A615)	947
LCC (A1035)	539
Epoxy-coated (A775)	10
XM-28	9
2205	8
Dual-coated (A1055)	5
2304	2
316LN	1

The total measured current flow in coulomb is indicative of the total amount of metal loss due to corrosion that has occurred in the steel specimens. For the carbon-steel bars in cracked concrete, the total current was 947 coulomb (**Table 1**). The three zinc or galvanized products exhibited significantly greater values than the carbon-steel bars and the LLC (A1035) bars exhibited a corrosion of 56% that of the carbon-steel bars (**Figure 1**). The epoxy-coated, dual-coated and stainless bars exhibited total corrosion amounts 95 times less than that of the carbon-steel bars.

The epoxy-coated, dual-coated and stainless bars exhibited total corrosion currents 95 times less than that of the carbon-steel bars.

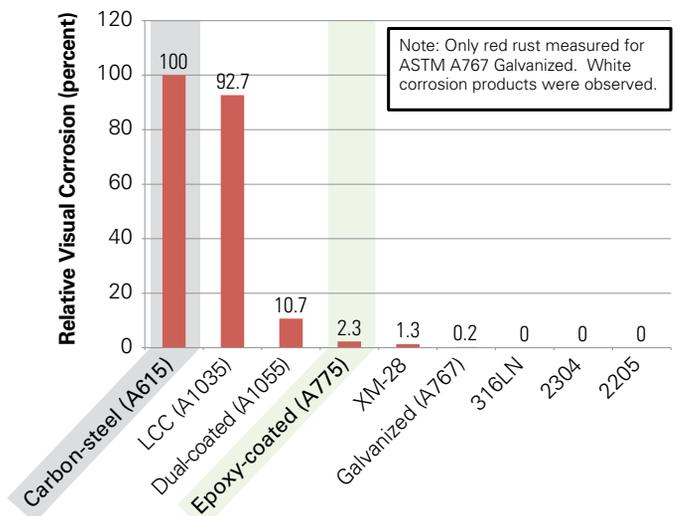
Figure 2: Relative Visual Corrosion.

Table 2: Visual Corrosion

Bar Type	Top Mat Corrosion (% of total bar area)
Carbon-steel (A615)	5.5
LCC (A1035)	5.1
Dual-coated (A1055)	0.59
Epoxy-coated (A775)	0.13
XM-28	0.07
Galvanized (A767)	0.01*
316LN	—
2304	—
2205	—
Tin-plated zinc-clad	*
Zinc-clad	*

*Note that the presence of zinc corrosion was not accounted for within the analysis.

The surface area of all longitudinal and transverse steel was 103.7 in.² From the visual observations, the amount of corrosion was documented (**Table 2**). Only reddish-brown (from red iron oxide) and blackish (from black iron oxide) corrosion were considered in this evaluation and any white corrosion products from zinc were ignored.

The amount of corrosion of the top carbon-steel bars was 5.5% of the total bar area. Using this as the baseline, the LCC (A1035) materials exhibited almost the same amount of corrosion as the carbon-steel bars (**Figure 2**). The dual-coated (A1055) bars exhibited 10 times less corrosion than the carbon-steel bars. The epoxy-coated (A775) bars exhibited 40 times less corrosion than the carbon-steel bars.

The XM-28 bars exhibited corrosion approximately 80 times less than that of the carbon-steel (A615) bars. The other stainless steel bars did not exhibit corrosion.

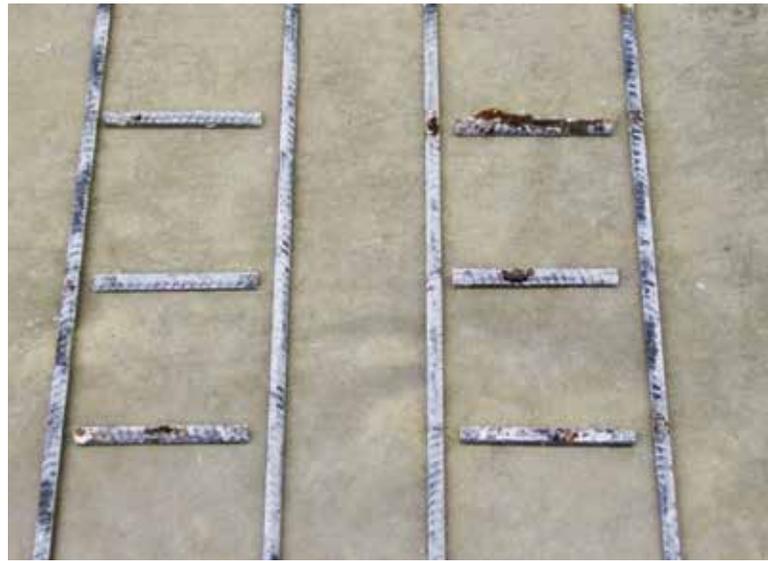
Overall corrosion on carbon-steel A615 bars (cracked specimen).

Both the carbon-steel and LCC (A1035) specimens had corrosion products in both the top and bottom mats. However, more corrosion products from iron oxides were located on the top mats, which is consistent with the electrical measurements that indicated negative currents.

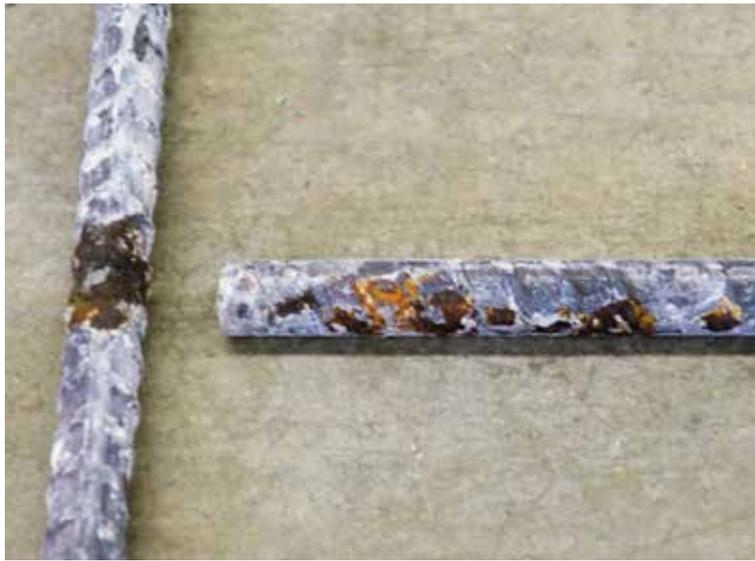
Close-up of corrosion on LLC A1035 bar (cracked specimen).

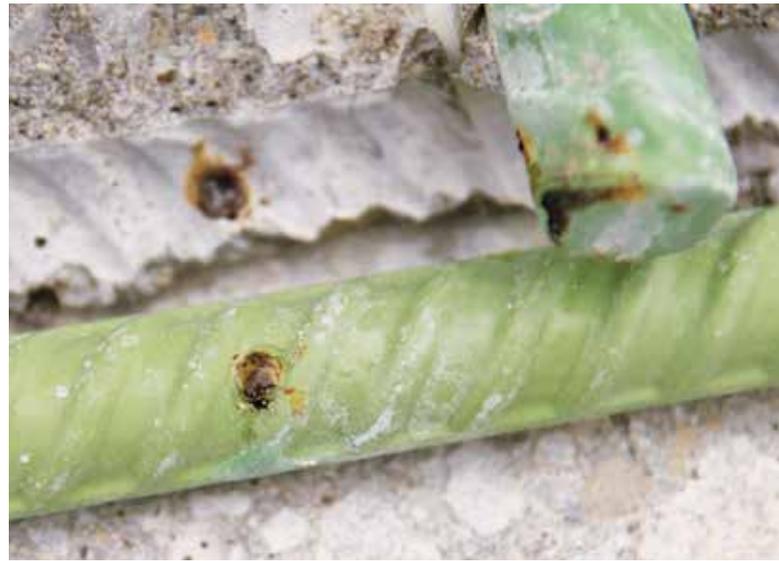
Close-up of corrosion on epoxy-coated A775 bar (cracked specimen).

Corrosion was limited to a local area on the epoxy-coated (A775) reinforcing; however, corrosion of the underlying base metal was observed at the ends of the transverse steel (where they had been patched and repaired prior to casting) and where the coating peeled. In addition, due to corrosion of the base metal underneath the epoxy coating, a spot where the coating was bulging was observed.
