Review of Papers —

CORROSION RESISTANCE

Of Epoxy-Coated Reinforcing Bars
in Florida Bridges

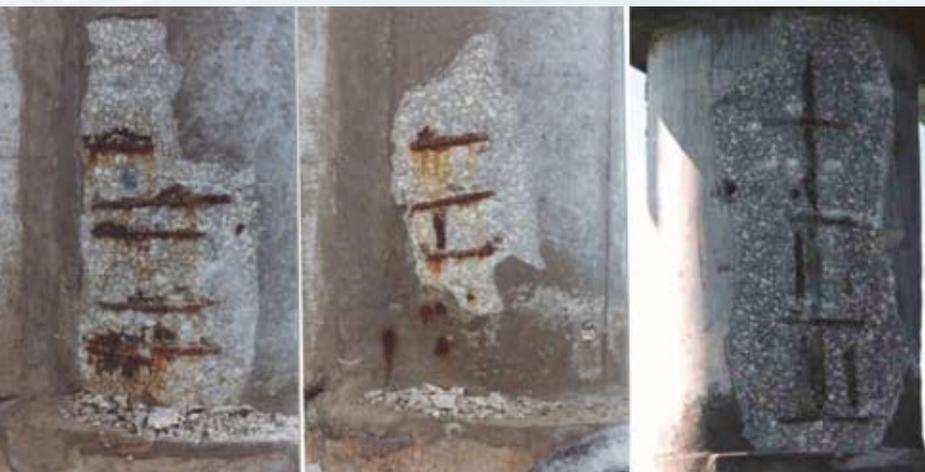
The five bridges that exhibited early age distress were classified in the two papers as Group 1. When spalls were found, they were of the order of 3 sq ft. Typical spalls are shown in **Figure 1**.

Figure 1: Typical spalls observed in bridge piers⁽¹⁾.

These bridges were built with permeable concrete that enabled rapid ingress of chloride ions. Substantial deviations from design concrete cover were also observed.

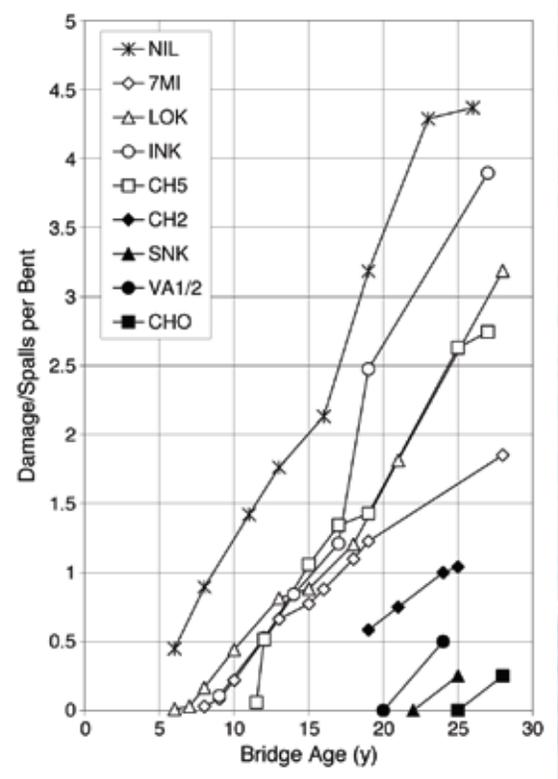
Figure 2: Count of spalls observed per bent⁽¹⁾.

Figure 2 shows the count of spalls per bent, plotted against the bridge age for the nine structures that exhibited spalling. As of 2010, only nine bridges of the 300 containing epoxy-coated bars have exhibited any visible corrosion-induced distress.

The models assume that the area of splash zone was 215 sq ft and a typical spall affects 3 sq ft. Diffusion, surface chloride and threshold values are shown in **Table 1**. As shown in **Figure 2**, the growth of concrete damage appeared to linearly increase with time. For Group 1, this assumption is consistent with a relatively small fraction of the rebar assembly causing much of the damage in the first decade or two, with that fraction representing areas where the rebar had experienced the most distress by the time it was put into service. The projections also successfully approximated the observed damage for the Group 2 bridges.

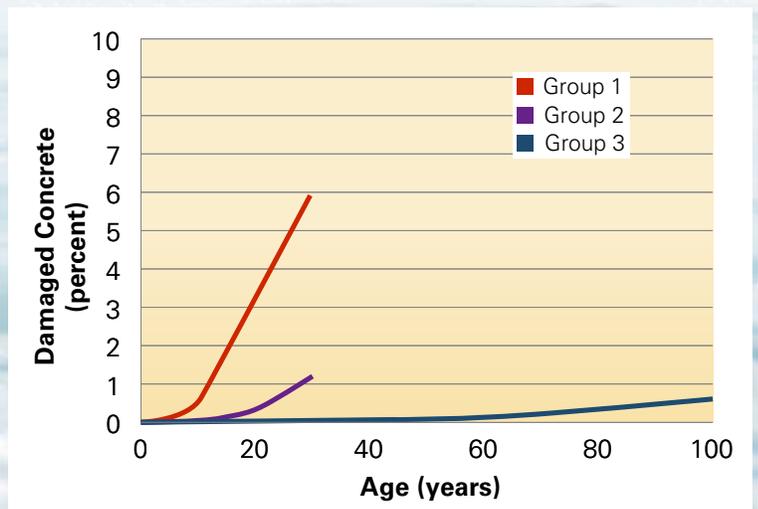
Figure 3 shows the predicted damage that is forecast for Group 1, 2 and 3 bridges, modified from the papers. The y-axis has been converted to describe the percentage of pier damage. After 30 years, the five bridges in Group 1 exhibit approximately 6 percent damage and the four bridges in Group 2 exhibit approximately 1 percent damage. Bridges in Group 3 demonstrate less than 1 percent damage, even after 100 years. Such limited damage is readily repairable and should not limit the use of epoxy-coated bars in these structures.

Figure 3: Percent of spalls for Groups 1, 2 and 3. (After Sagüés et al.)

Thus, the data of Sagüés et al. demonstrates that appropriately constructed concrete piers, built using epoxy-coat bars in Florida marine environments, can provide 100-year design life with minimal maintenance.

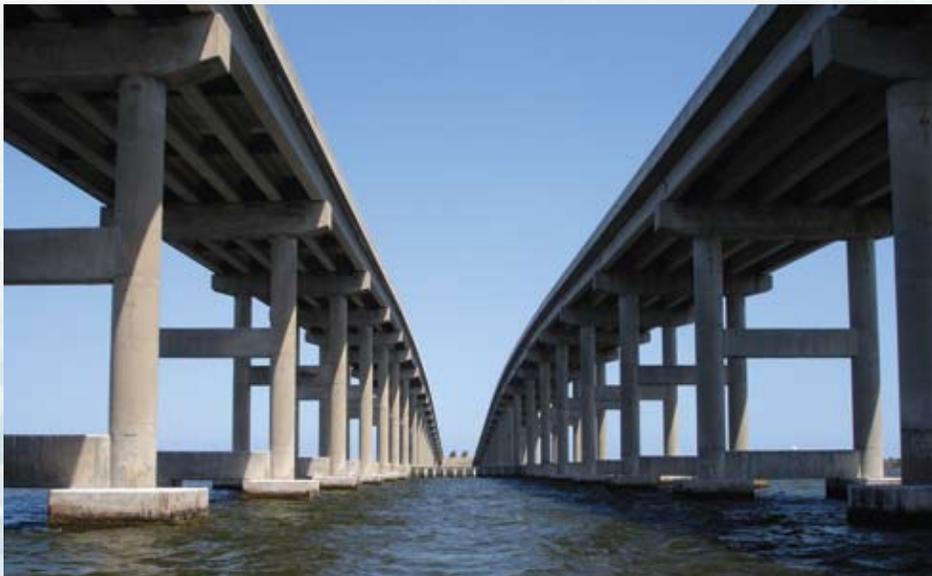
Additional research is recommended to address this specific issue; however, for companion bridges in Melbourne, Florida (**Figure 4**) containing epoxy-coated or uncoated bars, corrosion damage has been observed in the structure containing uncoated bars, while no distress was observed in the structure containing epoxy-coated bars.

Figure 4: Companion bridges containing either black (left) or epoxy-coated bars (right) in Melbourne Florida.
