CORROSION-RESISTANCE OF REINFORCING BARS: An Accelerated Test

Epoxy-coated bars have shown good corrosion protection in concrete structures since 1973. Recently, interest in other corrosion-resistant bar systems has resulted in new products being supplied to the marketplace. Tests were conducted by Wiss, Janney, Elstner Associates using a wide range of products including 15-year old epoxy-coated reinforcing bars that had been removed from salt-contaminated concrete. Results from the tests show that even old coated bars perform significantly better than other products. This work supports conclusions of other longer-term research, that epoxy-coated bars provide cost-effective corrosion protection.

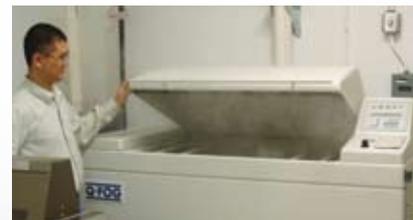
The testing is conducted in a closed chamber, where a salted solution is sprayed by means of a nozzle. This produces a corrosive environment in the chamber and thus, parts in it are attacked under this severe corroding atmosphere.

Reinforcing bar samples were tested in a fog cabinet for a period of 28 days. During this period they were exposed to a 5% sodium chloride fog at 35°C following the ASTM B117 protocol.

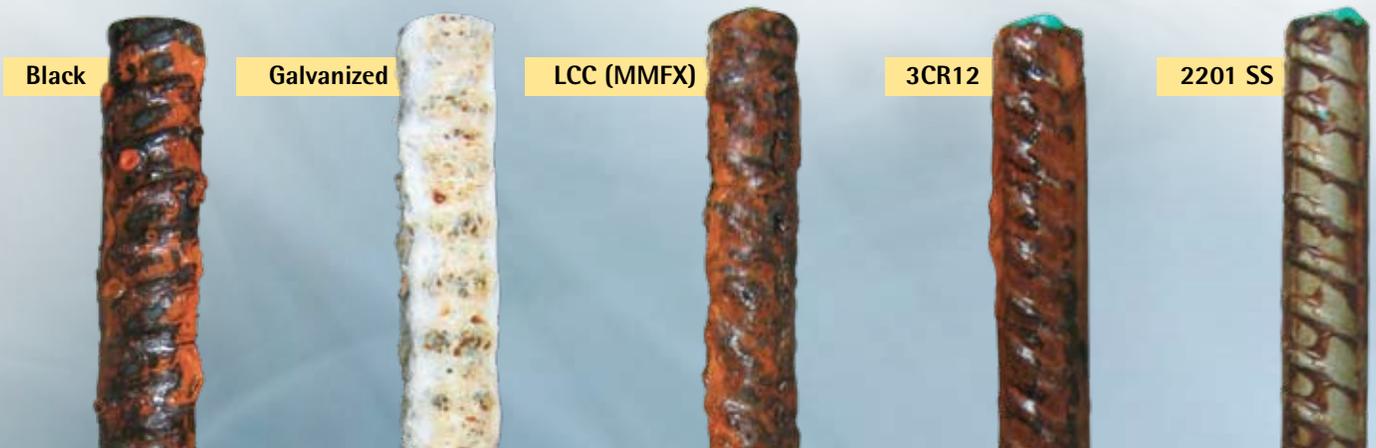
BARS AFTER 28 DAYS

All bars corroded extensively during the test period, and the corrosion aggressively progressed with time. Weight analysis shows that the bars experienced significant corrosion.

Both as-received and sandblasted bars corroded significantly and the corrosion aggressively progressed with time.

All galvanized bars experienced extensive corrosion. The zinc coating corroded first, producing a white-color corrosion product, and then the underlying carbon steel started to corrode, producing a rusty color. The rust color was prominent after 2 weeks of exposure. For the samples with drill holes, the exposed carbon steel at drilled holes was protected until the adjacent zinc coating was consumed. Weight loss analysis showed that these galvanized bars experienced extensive corrosion with very high corrosion rates. Average corrosion weight loss of the undamaged galvanized bars was about 30 percent higher than that of the as-received carbon steel bars.

The sandblasted bars corroded extensively. These experienced general corrosion attack at most areas and some deep pitting corrosion near the ribs. While corrosion of 3CR12 appeared to be extensive, its average corrosion was about half of the LCC (MMFX) and about one third the rate of the as-received carbon steel bars.

surfaces and corrosion appeared to progress with time. However, the cleaned bar showed that corrosion was rather superficial and no obvious pits were observed. Weight loss analysis yielded a very low average corrosion of about 3% of as-received carbon steel bars.

These stainless steel bars experienced some localized corrosion and this corrosion apparently progressed with time. The total amount of corrosion was superficial and such corrosion was speculated to have been induced by local contamination or crevices generated by the coating used to seal cut ends.

The new ECR bars with no defects had no corrosion throughout the testing program. The specimens with a drilled hole only corroded at the holes.

The bars extracted from a 15-year-old bridge deck performed very well with little corrosion. For the first seven days of exposure, corrosion only occurred at the drilled holes where carbon steel was exposed. Visual observation indicated that corrosion of the bars was minor. For all the ECR specimens, weight loss was so minor that it was not possible to effectively estimate actual corrosion rates. The epoxy coating adhesion did not affect the corrosion performance. Even bars with poor coating adhesion performed well in the test, which does not support conclusions of some researchers who have indicated that old coatings will provide little or no benefit.

1. Both as-received and sandblasted carbon steel reinforcing bars corroded at high corrosion rates. The sandblasted bars had corrosion rates higher than the as-received bars. Pitting corrosion was also noted.

2. The LCC (MMFX) bars meeting ASTM A1036 and stainless steel 3CR12 reinforcing bars meeting ASTM A955 offered some improvement in corrosion protection and yet still corroded rapidly in this test environment.

3. While the zinc offered protection to the underlying steel, the galvanized reinforcing bars meeting ASTM A767 corroded extensively. Within 2 weeks, the zinc layer was essentially consumed and underlying steel corrosion was observed.

4. Stainless steel 2201 reinforcing bars meeting ASTM A995 exhibited significant surface corrosion; however, only moderate corrosion was measured in this test.

5. Stainless steel 316LN and 2205 stainless reinforcing bars meeting ASTM A995 had very high corrosion resistance and only experienced minor corrosion likely due to presence of crevices or steel contamination.

6. The new epoxy-coated reinforcing bars meeting ASTM A775 performed very well and corrosion was only observed at drilled holes.
7. The epoxy-coated reinforcing bars removed from a 15-year old deck performed well during the test. Corrosion was regarded as being minor and only took place at the drilled holes and at existing defects in the coating.

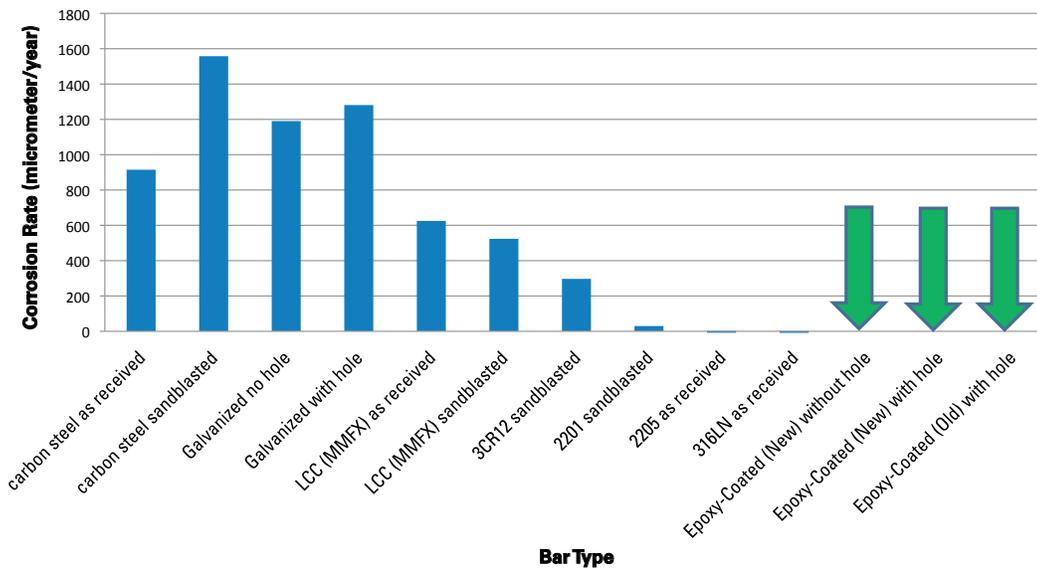
Bar Type	Condition	Average Corrosion Rate Micrometer/Year
Carbon Steel	as received	914.7
Carbon Steel	sandblasted	1557.6
Galvanized	no hole	1190.2
Galvanized	with hole	1281.0
LCC (MMFX)	as received	625.0
LCC (MMFX)	sandblasted	523.6
Stainless steel 3CR12	sandblasted	296.8
Stainless steel 2201	sandblasted	29.7
Stainless steel 2205	as received	1.9
Stainless steel 316LN	as received	1.2
Epoxy-Coated (New)	without hole	*
Epoxy-Coated (New)	with hole	*
Epoxy-Coated (Old)	with hole	*

The method using weight loss data to determine corrosion rate was not applicable to epoxy-coated rebar (ECR). Corrosion rate of ECR, however, was minor and estimated to be in the same order as stainless steel 316LN and 2205.

The salt spray tests used for this evaluation were very aggressive to some steels and measured corrosion rates were much higher than that expected for bars embedded in concrete. Nevertheless, the observed corrosion performance provides a simple and useful comparison of the corrosion resistance of the various bar types.
