Re: Veterans Bridge near Steubenville Ohio

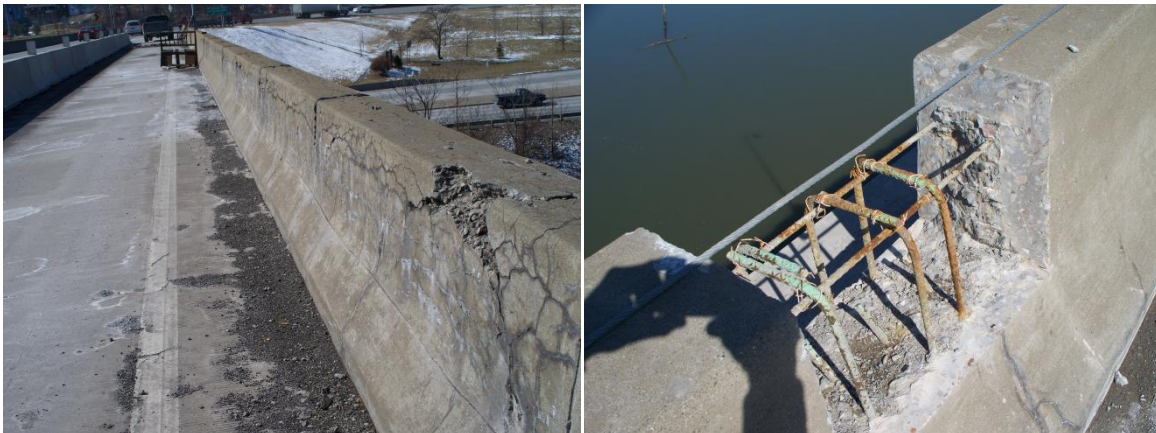
I have reviewed the photos carefully and have found that your conclusions are completely false. As shown in the following photos, the concrete itself is deteriorating, not the rebar and it is this deterioration that has led to repair. It is more than likely that during the repair process, the epoxy-coated reinforcing steel has been disrupted. One would expect to observe removal of the ECR during a repair process.
