What We Have Learned About the Use and Performance of Epoxy-Coating Reinforcing Bars

TRB 2010, Washington DC

David McDonald, Ph.D., P.E., FACI

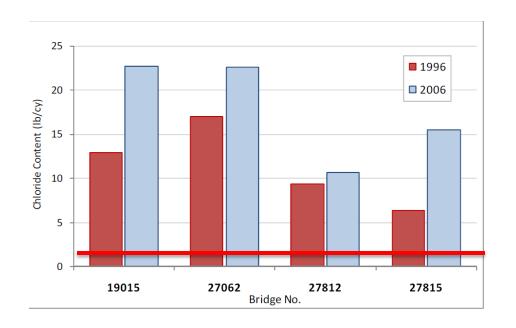
Minnesota Department of Transportation 2008

- Four bridges
 - 1973 to 1978
- Overall condition
 - good to very good, with no or modest levels of corrosion activity.
- Corrosion constrained joints over piers
- Amount of delamination in all decks is very low

Delaminations in 1996 and 2006

Bridge	Total Delaminated Area 1996		Total Delaminated Area 2006	
	(ft^2)	(%)	(ft^2)	(%)
19015	0	0.0%	39	1.1%
27062	2	0.0%	84	1.1%
27812	0	0.0%	20	0.3%
27815	0	0.0%	21	0.4%

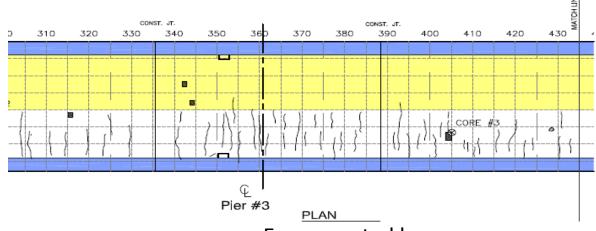
Bridge 2930, West Virginia

Epoxy-coated bars

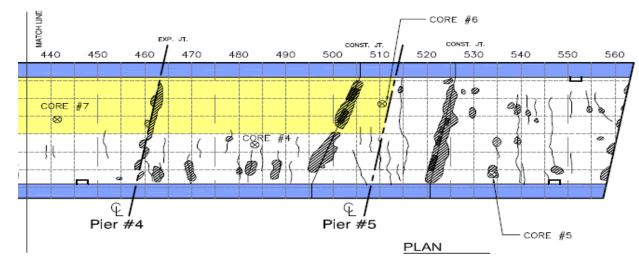
Black Bars

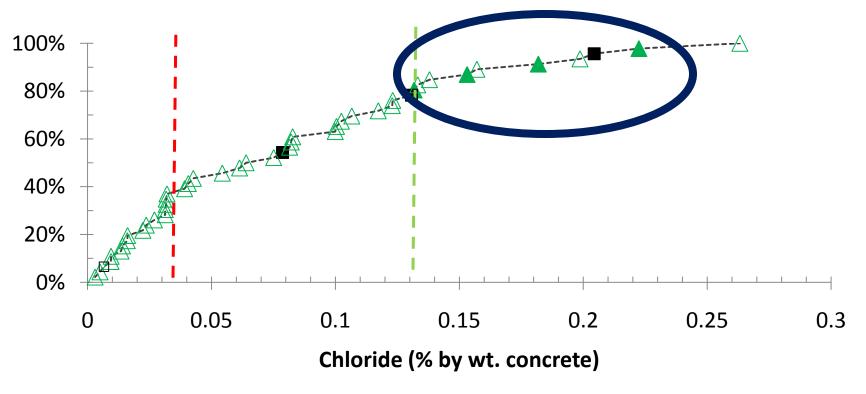
Effect of chloride level

- ▲ Epoxy-coated: active corrosion Uncoated: active corrosion
- △ Epoxy-coated: no active corrosion □ Uncoated: no active corrosion

----- Cumulative distribution

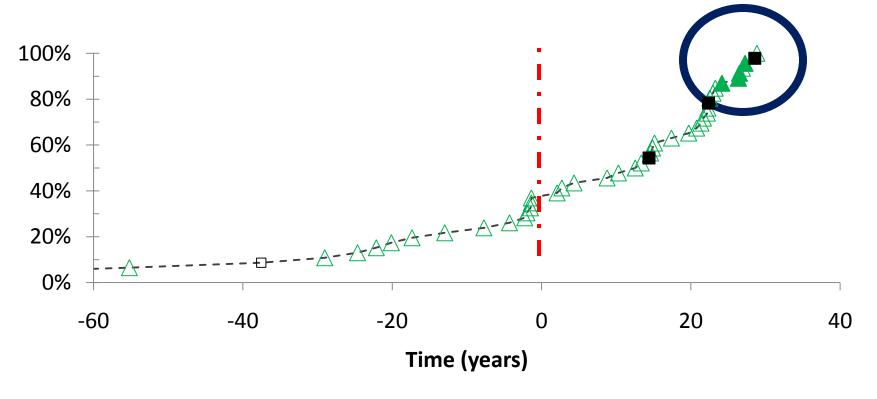
Effect of time

- Epoxy-coated: no active corrosion ▲ Epoxy-coated: active corrosion
- □ Uncoated: no active corrosion
- Uncoated: active corrosion

Cumulative distribution

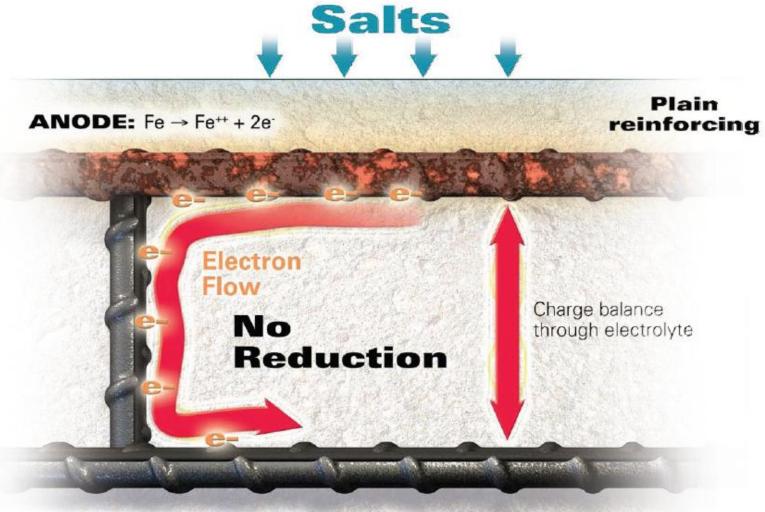
Black bars

CATHODE: $1/2 \text{ H}_2\text{O} + 1/4 \text{ O}_2 + \text{e}^- \rightarrow \text{OH}^-$

Plain reinforcing

- The cathodic reaction is important
 - Use ECR on both top and bottom mats coated to reduce cathodic area
 - Most agencies are now doing this
 - But some are not...
- Even damaged bars perform considerably better than black bars

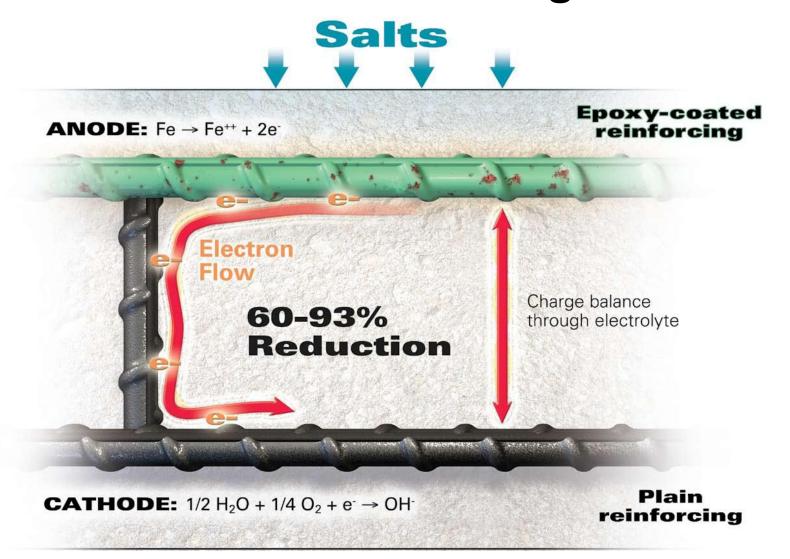
Epoxy-Coated Bars - Top mat only with deliberate damage

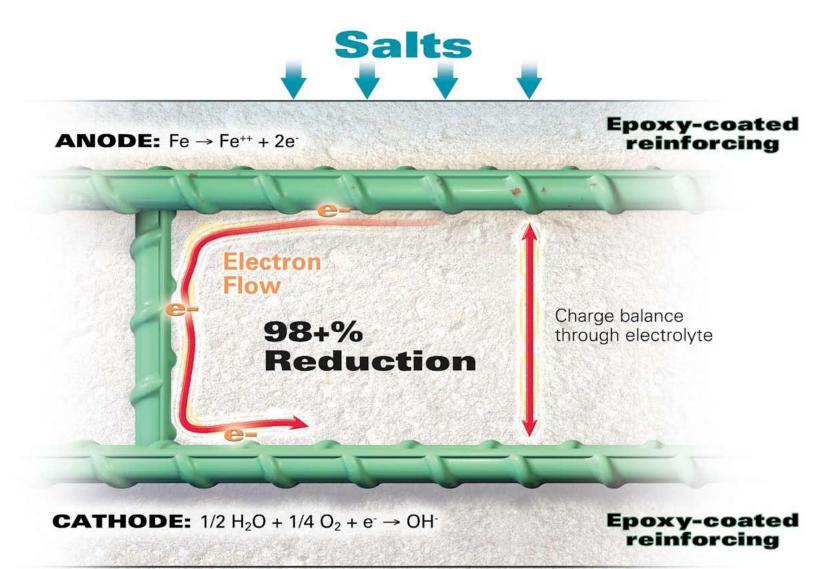
Epoxy-Coated Bars - Both mats with deliberate damage

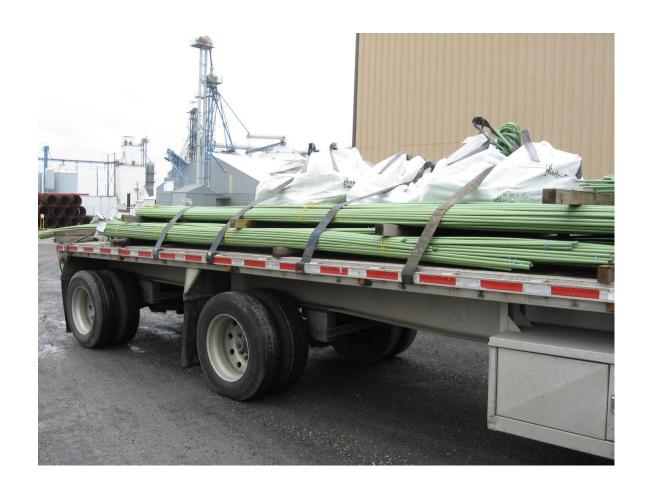
Proper loading

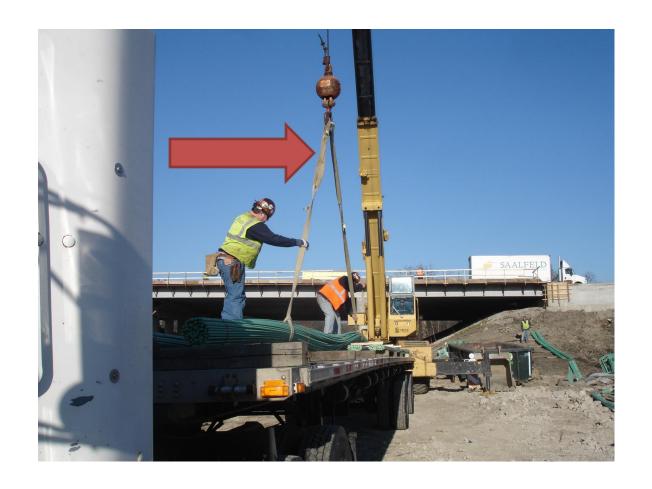
Good lifting practices

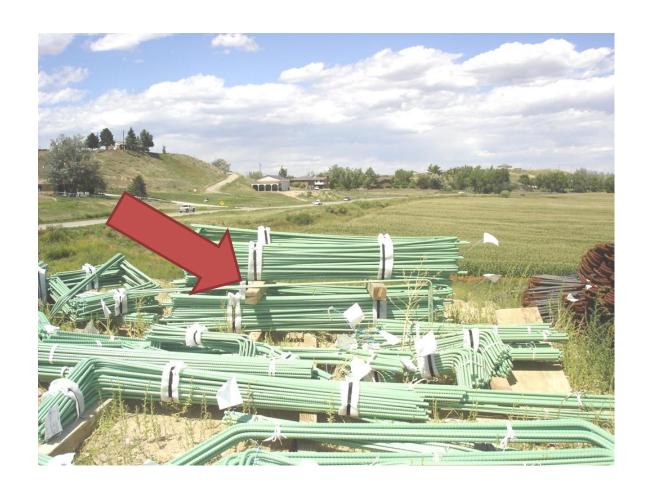
Appropriate Storage

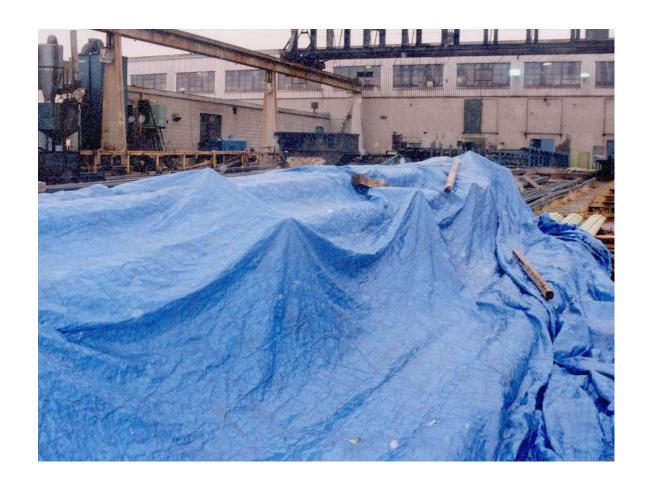
Covering to protect from UV

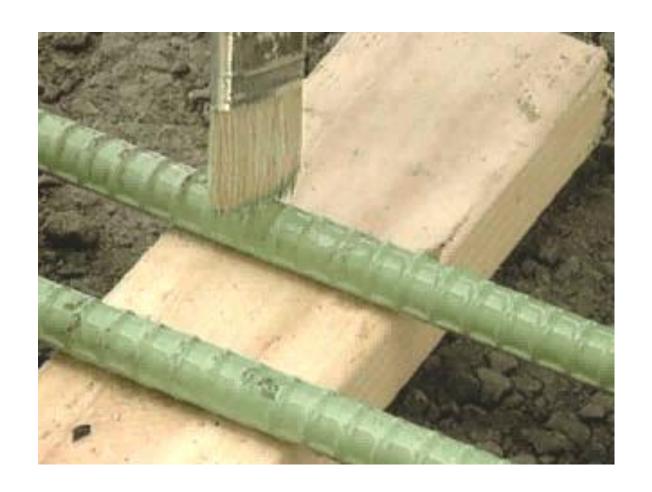
Repair ALL damage

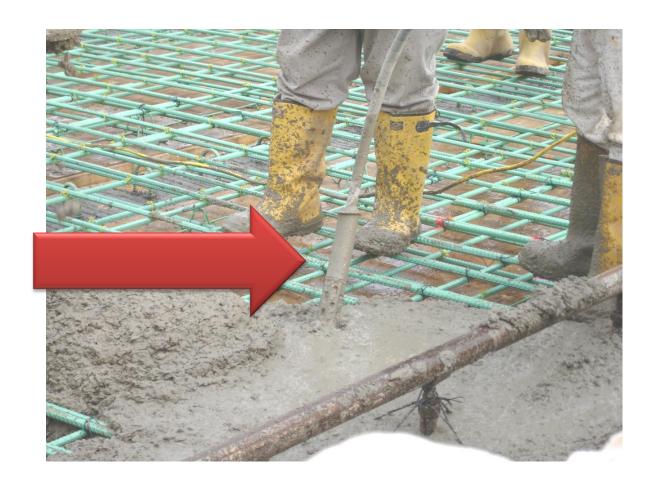
Use non-metallic vibrator heads
