PERFORMANCE OF BRIDGE DECKS CONTAINING EPOXY-COATED REINFORCING BARS

David McDonald, Ph.D., P.E., Epoxy Interest Group of CRSI, Schaumburg, IL

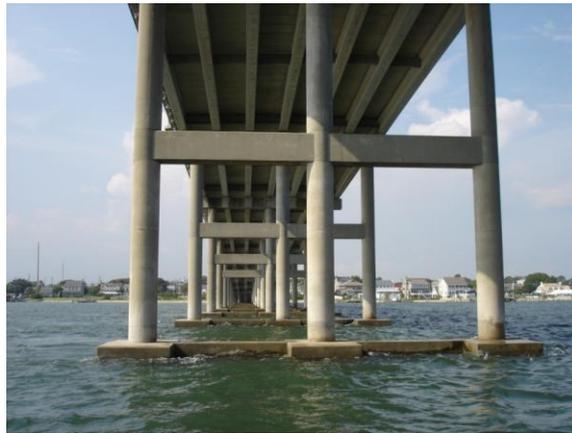
Figure 1: Bridge at Atlantic Beach, N.C.

Marine Study in Georgia and North Carolina: In 2007, a field evaluation of four bridges in Georgia and North Carolina found no concrete distress induced by corrosion of epoxy-coated bars in the substructure of four bridges^[8]. The bridge at Atlantic Beach is shown in Figure 1. It was reported that coating adhesion was a poor indicator of bar performance, even though most bars examined from these bridges had greater coating damage and lower coating thickness than admissible by current specifications governing the use of epoxy-coated reinforcing steel.

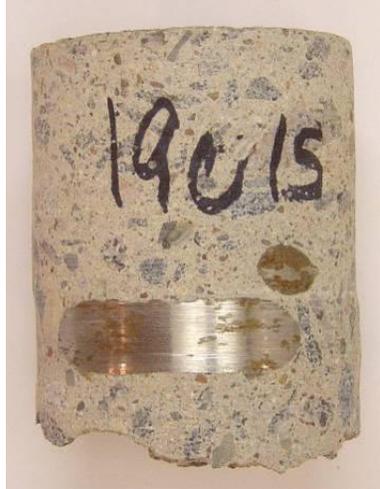
Figure 2: Core DCS1 from bridge 27062

Closer evaluation of the chloride in bridge 27062 found that only one bar was subjected to this high value. This core (DSC1) had a chloride value of 5.4 lb/yd³ at the level of the bar. Despite this high chloride value, delamination of the concrete was not present (See Figure 2).

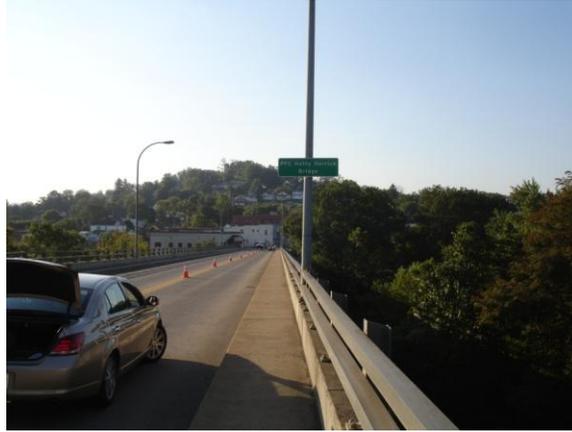
Figure 3: Bridge 2930 in West Virginia

2009 EIG Sponsored Studies: In September 2009, field studies were conducted by Wiss, Janney, Elstner Associates (WJE), on several bridges in West Virginia. Bridge 2930 was constructed in 1974. In 1993, a significant number of surface delaminations were observed near the southern section of the deck. This corrosion affected only 0.225 percent of the deck area and covered approximately 40 ft². At that time, this distress was linked with the performance of epoxy-coated reinforcing steel. However, recent studies of this deck found that the bridge consists of two sections, a northern 15000 ft² section, containing epoxy-coated bars in both mats and a southern 3000 ft² section containing uncoated reinforcing bars only. No delaminations were found in the epoxy-coated bar section and substantial damage was observed in the uncoated bar section.

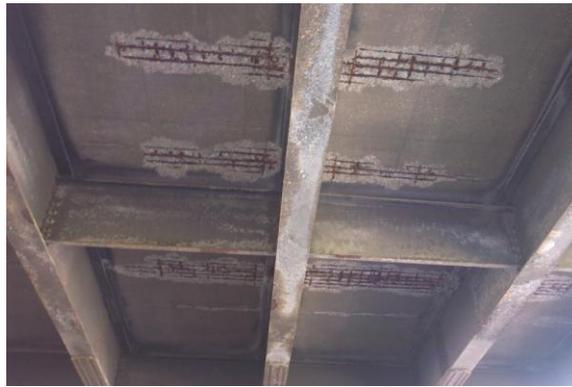
Figure 6: Deterioration of bridge deck using uncoated bars as bottom mat and epoxy-coated bars as the top mat

A problem with using uncoated bars in the bottom of a deck that utilizes epoxy-coated top bars is that most decks will crack and provide a pathway for chloride ions to the bottom layer of reinforcing steel. Eventually, the bottom mat of the deck start corroding, reducing the service life of the deck. An example of this type of distress is shown in Figure 6.
