# **EPOXY-COATED REINFORCING STEEL BARS IN NORTHERN AMERICA**

**David McDonald**

Managing Director, Epoxy Interest Group of CRSI

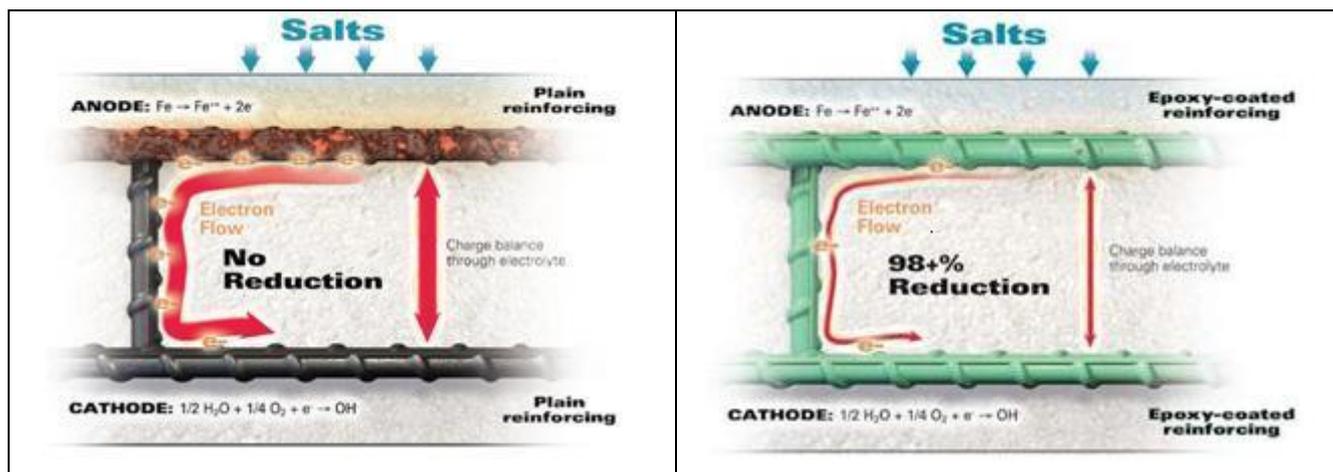
Figure 1a shows corrosion in concrete for uncoated steel. When the passive film on the steel is disrupted, either by a reduction in pH or by the ingress of chloride ions, corrosion initiates at the anode. Iron ions form, releasing electrons. The electrons flow through the steel bars to the cathode. At the cathode, water and oxygen combine with the electrons to form hydroxide. In order to balance the charges, the iron ions and hydroxide flow through the electrolyte or liquid in the concrete. The iron ions released at the anode react with oxygen to form corrosion products or rust, which occupy a greater volume than the original steel. It has been calculated that the amount of corrosion required to crack concrete is approximately 25 micron (0.001 in.)<sup>[7]</sup>.

**Figure 1a: Corrosion of uncoated bars in concrete slab**  
**Figure 1b: Corrosion of coated bars in concrete slab**

Where epoxy-coated steel is used in the top mat of a slab only, anodes can only form at breaks or holes in the coating, thus reducing the total corrosion; however, cathode locations are freely located. Thus, while the total corrosion is reduced, laboratory tests have demonstrated 60-93 percent

reduction in corrosion rates when epoxy-coated bars are used in a top mat only [8]. Another problem with using black bars in the bottom of a deck that utilizes epoxy-coated bars is that most decks will crack and provide a pathway for chloride ions to the bottom layer of reinforcing steel. Eventually, the bottom mat of the decks start corroding, reducing the service life of the deck.

Where epoxy-coated steel is used in both mats as shown in Figure 1b, anodes may form at breaks or holes in the coating; however, cathode locations are also limited, reducing the ability for electrons to flow. Laboratory tests have demonstrated over 98 percent reduction in corrosion rates even when damage is present<sup>[8]</sup>.
