Service Life Extension of Northern **Bridge Decks** containing Epoxy-Coated Reinforcing Bars

Wiss, Janney, Elstner Associates, Inc.
330 Pfingsten Road
Northbrook, Illinois 60062

Concrete Reinforcing Steel Institute
933 North Plum Grove Road
Schaumburg, IL 60173

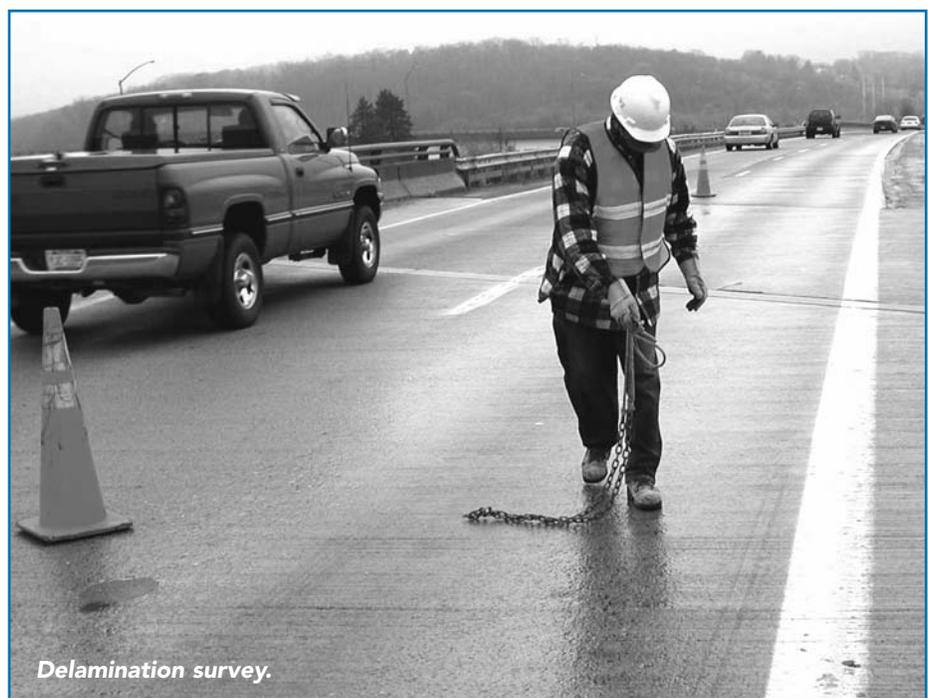
The first item in the overall condition assessment was a detailed visual examination and delamination survey performed on each bridge deck. (photo below) The damage level of each deck was calculated as the ratio of the total damaged surface area located in the inspected deck area (including spalls and delaminations) to the total surface area inspected. The crack density (ft/ft^2) was calculated by dividing the measured total length of the identified cracks by the total surface area.

Delamination survey.

At right: Delamination survey using chain dragging methods.
