SUMMARY OF THE IMPACT OF CONCRETE CRACKING ON

# Bridge Decks Constructed with Epoxy-Coated Reinforcing Bars

Iowa Department of Transportation  
and Iowa Highway Research Board

Center for Transportation Research  
and Education (CTRE) and the  
Civil, Construction, and Environmental  
Engineering Department at  
Iowa State University  
Ames, Iowa

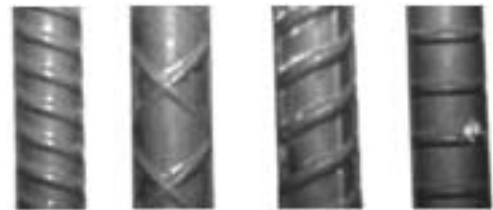
Most, if not all, of the epoxy on the reinforcing bar samples was discolored. Examination under a scanning electron microscope indicated that the severely discolored epoxy coating had a network of micro-cracks on the surface. Not known is the cause of these micro-cracks or their impact on the epoxy coating's ability to protect the reinforcing bar. However, because these micro-cracks appear to be surficial, their significance may be minimal.

Hardness of the epoxy coating was measured on the reinforcing bars from the core samples to evaluate whether there was any relationship between epoxy hardness and reinforcing bar condition (i.e., harder epoxy may be more brittle and subject to damage that would allow chloride to infiltrate) or epoxy hardness and chloride content (i.e., high chloride content may cause the epoxy coating to be harder). No such relationships were observed from the data.

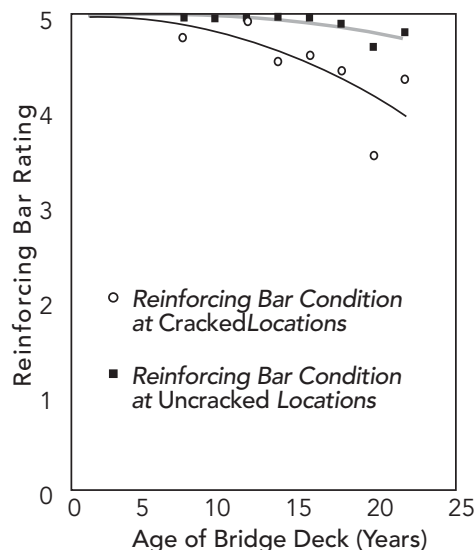
**Figure 1**

The relationship between the epoxy-coated reinforcing bar rating and the age of the bridge deck has been developed for both cracked and uncracked conditions. A graphical representation of this relationship is shown in Figure 1, along with the

weighted average of data collected from the representative Iowa bridges. These relationships were used to determine the functional service life of the bridge decks reinforced with epoxy-coated reinforcing bars.

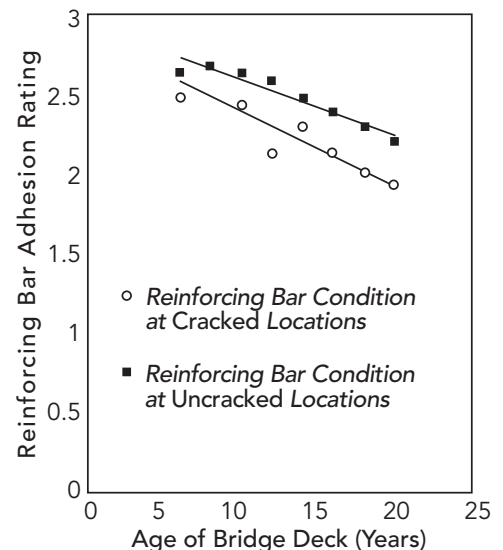
**Figure 2**

Epoxy coating bond adhesion measurements revealed that coating adhesion decreases as time increases, as shown in Figure 2. The data also indicate that the epoxy coating adhesion collected from uncracked locations is better than that from cracked locations.
