REPORTING ON INDUSTRY NEWS, NOTEWORTHY APPLICATIONS & NEW DEVELOPMENTS ON FUSION BONDED EPOXY COATINGS FOR CORROSION PROTECTION OF REINFORCING STEEL

## Runway 10-28 at Hartsfield-Jackson Atlanta International Airport (ATL) uses 2,033 tons of epoxy-coated rebar

## CRSI sponsors visual test for corrosion-resistance in reinforcing bars

## I-580 Extension—Galena Creek Bridge, longest concrete arch bridge in U.S.

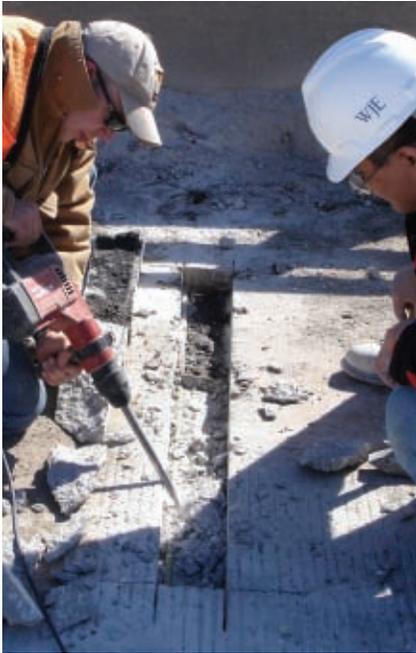
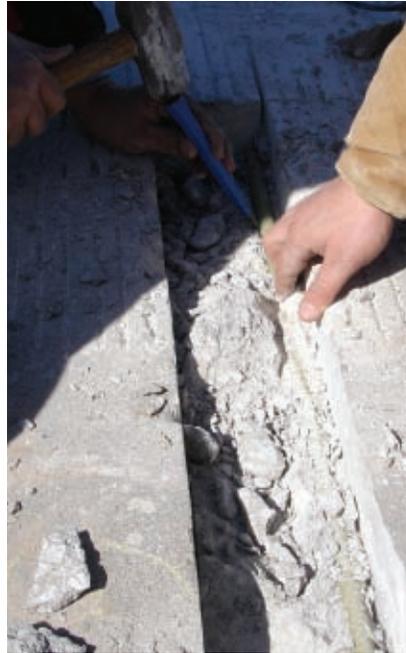
Extraction procedure of 15 year old epoxy-coated rebar used in this study

The epoxy-coated bars and galvanized bars were tested as-received and with 1/16-inch drill holes. Recently produced ECR and ECR retrieved from a bridge deck about 15 years old were used.

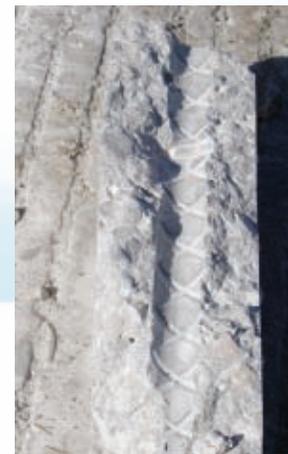
Concrete core sample with smooth, unstained rebar impression

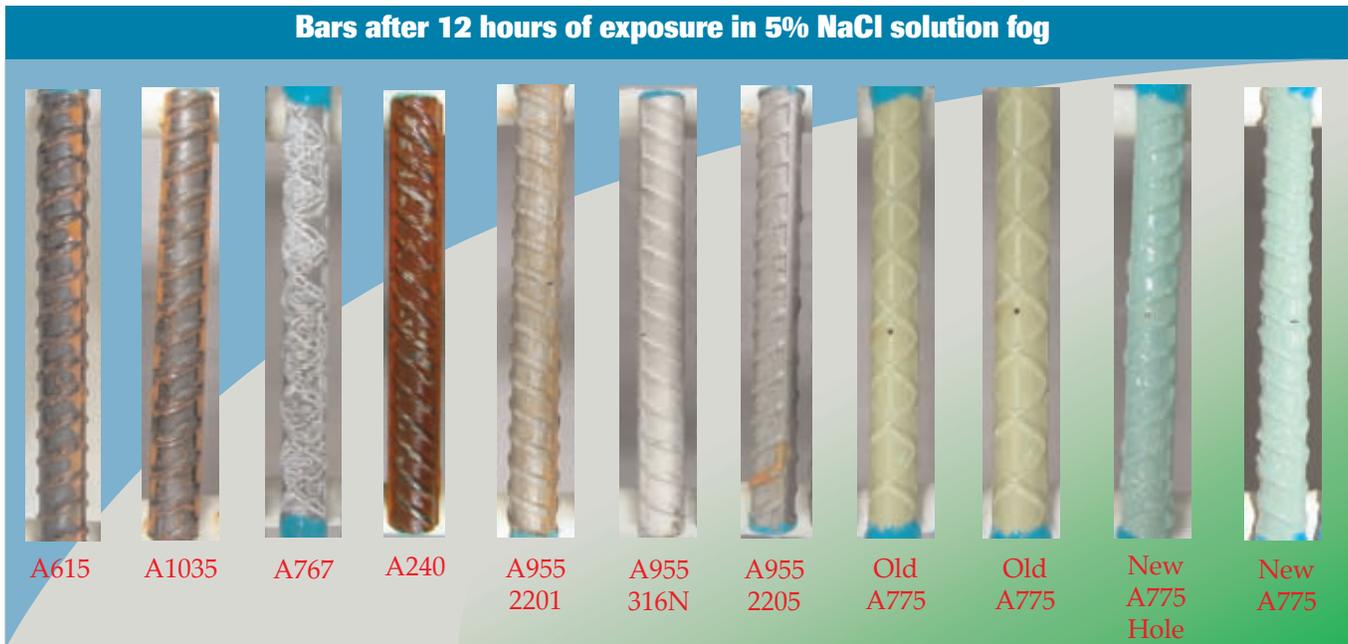
All bars tested 'as received' except the epoxy-coated bar indicated had a 1/16 inch hole drilled

After just 12 hours of exposure, A615, A1035, A767 and A240 bars showed progressive corrosion

Both as-received and sandblasted bars corroded extensively and the corrosion aggressively progressed with time. Weight analysis shows that the bars experienced significant corrosion.

Both as-received and sandblasted bars corroded significantly and the corrosion aggressively progressed with time.

While galvanized bars with two different types of deformation were tested, all the bars experienced extensive corrosion of similar pattern. The zinc (Zn) coating corroded first, producing a white-color corrosion product. Then the underlying carbon steel started to corrode, producing a rusty color. Rust color was prominent after 2 weeks of exposure. The exposed carbon steel at drilled holes was protected until the adjacent zinc coating was consumed. Weight loss analysis showed that these galvanized bars experienced extensive corrosion with very high corrosion rates. Average corrosion weight loss of the undamaged galvanized bars was about 30 percent higher than that of the as-received A615 bars.

The sandblasted bars corroded extensively. After cleaning, it was observed that the bars experienced general corrosion attack at most areas and also some deep pitting corrosion near ribs. While corrosion of 3Cr12 appeared to be extensive, its average corrosion was about half of the A1035 and about 1/3 the rate of the as-received A615 steel bars.

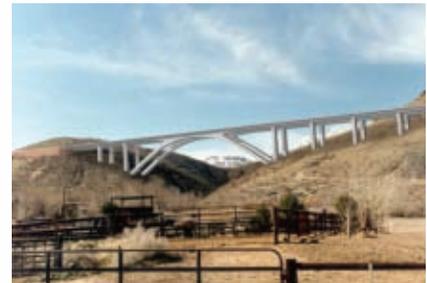
Galena Creek Bridge

Originally, the arch was to be constructed using segmental construction. However, after considerable thought, a less customary option, a pilot truss arch bridge, was chosen since it would be easier and cheaper. Pilot truss arch construction is characterized by erecting a steel truss (a web-like assembly of smaller beams that makes it stronger and lighter than a single beam or girder) in the shape of an arch first, then using this to support the formwork, steel reinforcing and concrete.

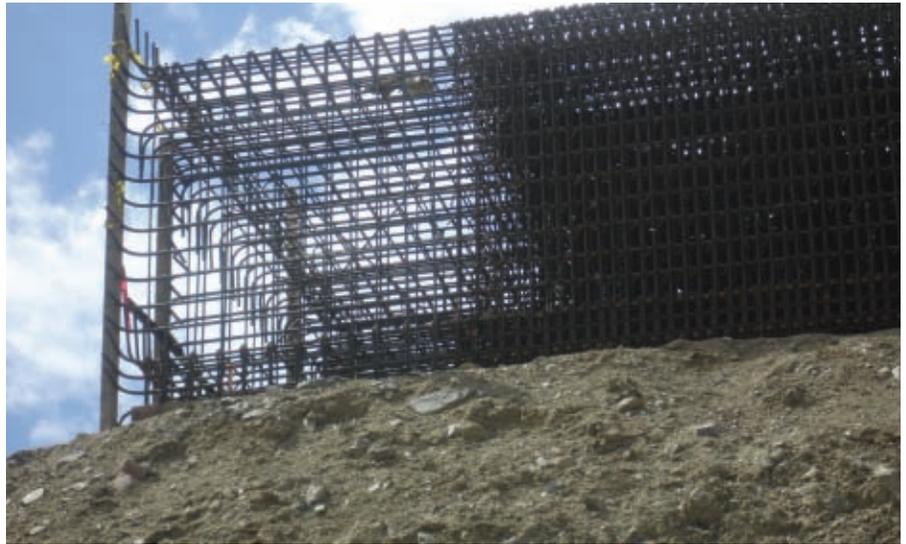
Reinforcing cage for Galena Creek Bridge Arch

- ~ Maximum height of bridge is 302 feet
- ~ Arch span of 663 feet
- ~ Arch section nearly 20 feet by 12 feet
- ~ Constructed with pilot truss rather than the typical segmental method
