REPORTING ON INDUSTRY NEWS, NOTEWORTHY APPLICATIONS &
NEW DEVELOPMENTS ON FUSION BONDED EPOXY COATINGS
FOR CORROSION PROTECTION OF REINFORCING STEEL

Runway 10-28 at Hartsfield-Jackson Atlanta International Airport (ATL) uses 2,033 tons of epoxy-coated steel bars

CRSI sponsors visual test for corrosion-resistance in reinforcing bars

I-580 Extension—Galena Creek Bridge, longest concrete arch bridge in U.S.

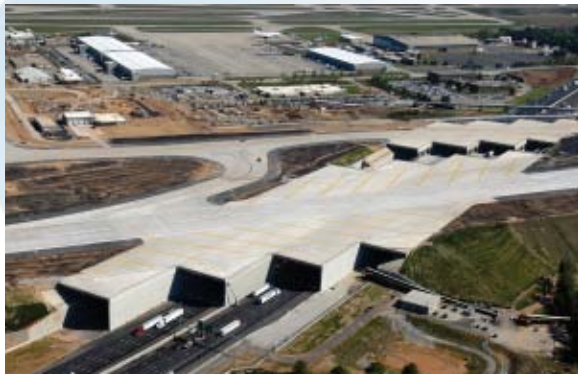
Aerial view of Interstate 285 and box culverts

Runway 10-28 crosses over ten lanes of traffic on Interstate 285, with two-thirds of the runway pavement on the west side and the remainder across the road on the east. Although the unique bridge culvert spans 10 lanes, expansion is possible up to 18 lanes. An impressive size, the main

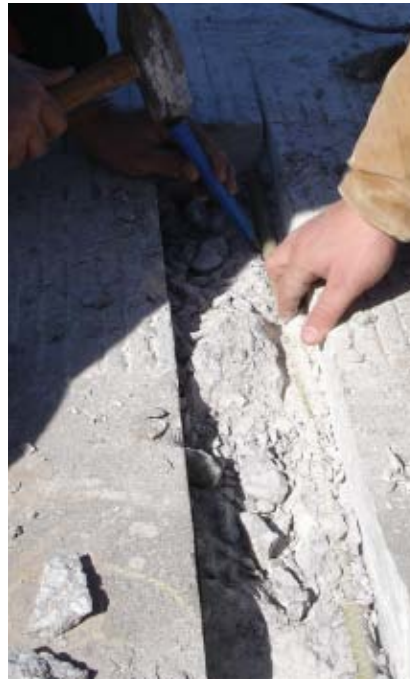
Extraction procedure of 15 year old epoxy-coated rebar used in this study

The epoxy-coated bars and galvanized bars were tested as-received and with 1/16-inch drill holes. Recently produced epoxy-coated reinforcing (ECR) and ECR retrieved from a bridge deck about 15 years old were used. Chloride analysis of the concrete indicated that the chloride level was twice the threshold level.

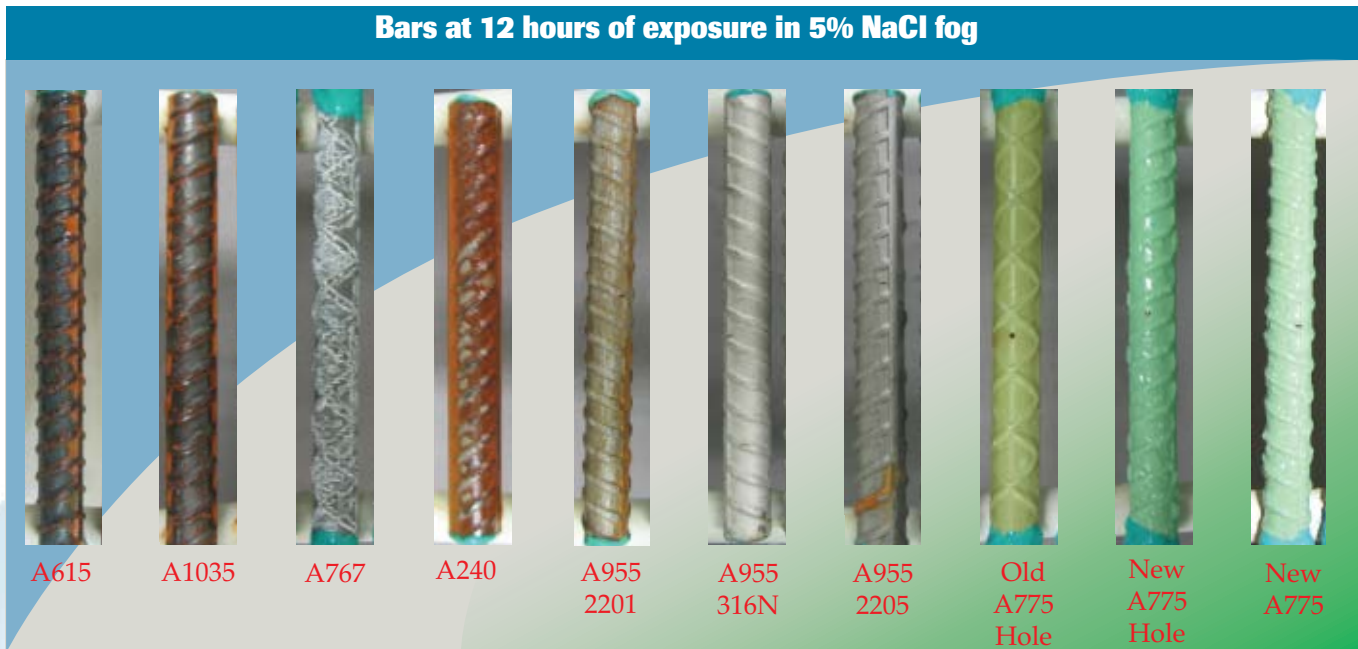
After just 12 hours of exposure, A615, A1035, A767 and A240 bars showed progressive corrosion

Both as-received and sandblasted bars corroded extensively and the corrosion aggressively progressed with time. Weight analysis shows that the bars experienced significant corrosion.

Both as-received and sandblasted bars corroded significantly and the corrosion aggressively progressed with time.

While galvanized bars with two different types of deformation were tested, all the bars experienced extensive corrosion of similar pattern. The zinc (Zn) coating corroded first, producing a white-color corrosion product. Then the underlying carbon steel started to corrode, producing a rusty color. Rust color was prominent after 2 weeks of exposure. The exposed carbon steel at drilled holes was protected until the adjacent zinc coating was consumed. Weight loss analysis showed that these galvanized bars experienced extensive corrosion with very high corrosion rates. Average corrosion weight loss of the undamaged galvanized bars was about 30 percent higher than that of the as-received A615 bars.

The sandblasted bars corroded extensively. After cleaning, it was observed that the bars experienced general corrosion attack at most areas and also some deep pitting corrosion near the ribs. While corrosion of 3Cr12 appeared to be extensive, its average corrosion was about half of the A1035 and about 1/3 the rate of the as-received A615 steel bars.

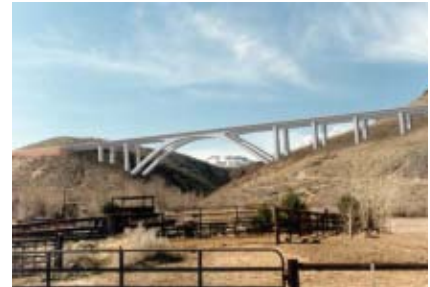
Galena Creek Bridge

Originally, the arch was to be constructed using segmental construction. However, after considerable thought, a less customary option, a pilot truss arch bridge, was chosen since it would be easier and more economical to build. Pilot truss arch construction is characterized by erecting a steel truss (a web-like assembly of smaller beams that makes it stronger and lighter than a single beam or girder) in the shape of an arch first, then using this to support the formwork, reinforcing steel and concrete.
