# CORROSION RATES

## Of Select Reinforcing Bars In Macrocell Tests

*A comparison of ASTM A775 epoxy-coated and  
ASTM A1035 low-carbon, chromium reinforcing bars with  
requirements for ASTM A955 stainless-steel reinforcing bars*

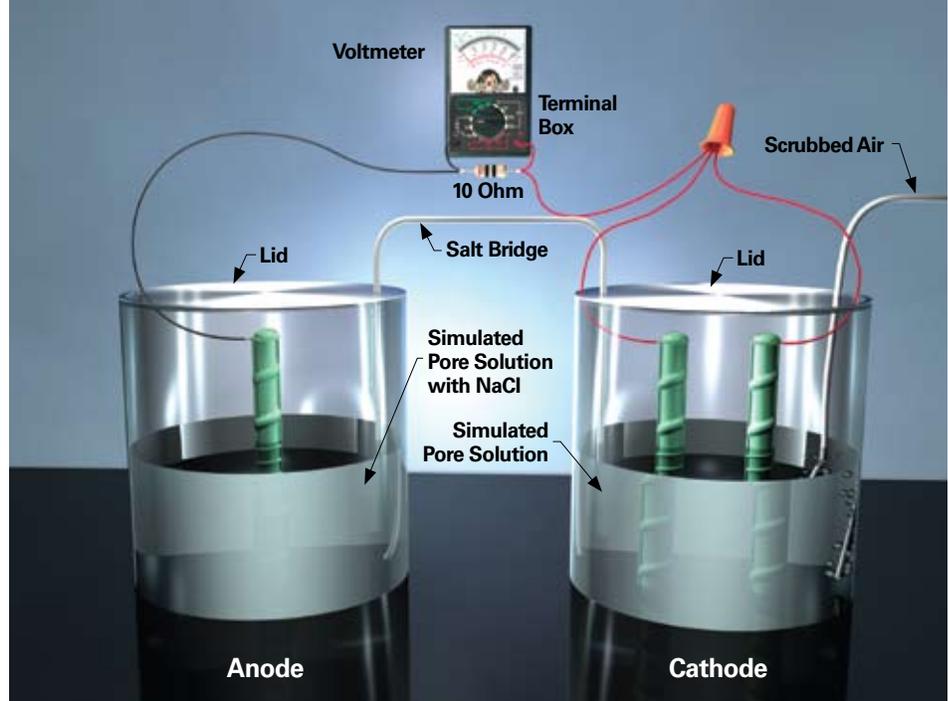
Schematic Diagram showing the test configuration.

Appendix A2 of ASTM A955 has been used to determine appropriate stainless-steel alloys for use in reinforcing concrete. The test consists of two containers, each containing one or two reinforcing bars. One container holds two bars, suspended in a solution of simulated concrete pore water, while the other container holds a single bar suspended in a solution of simulated pore water with additional sodium chloride. A salt bridge is connected between the two containers to enable ionic flow to occur. The bars are connected using a resistor, which enables any electrical current between the two sets of bars to be measured. From the measurements, the amount of steel corrosion during the 15-week test can be readily determined.

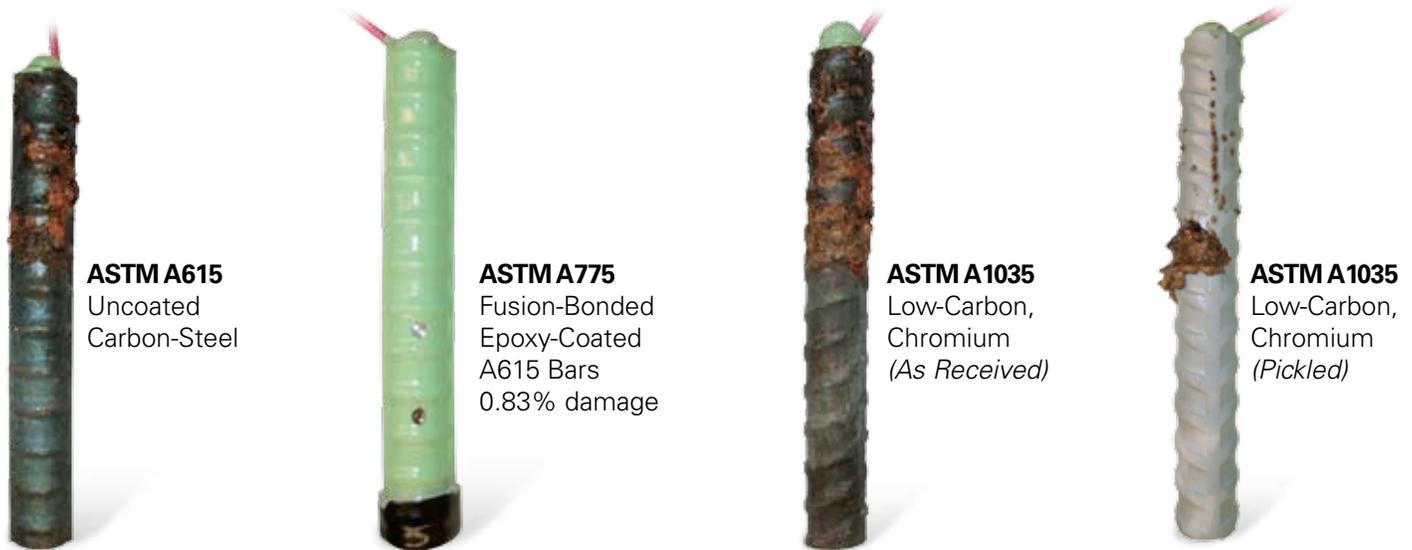
**Figure 5: Visual condition of bars at the end of the testing program. Note the minimal corrosion of the epoxy-coated bars compared with those of the ASTM A615 and A1035 bars.**

At the end of the testing program, the specimens were visually examined for corrosion. This visual examination found substantial corrosion on the ASTM A615 and A1035 bars, with minimum corrosion on the ASTM A775 bars.

5. Significant visual corrosion was observed on the ASTM A1035 samples and this corrosion appeared to be similar to that of the uncoated A615 bars.
6. Claims that ASTM A1035 bars perform like stainless-steel cannot be supported.

9. Minimal visual corrosion was observed on the bars meeting ASTM A775.
