anti-corrosion times

Reporting on industry news, noteworthy applications and new developments of the fusion bonded coating system for corrosion prevention.

Published by CRSI — Epoxy Coating Committees 933 N. Plum Grove Road, Schaumburg, IL 60173-4758 312-490-1700

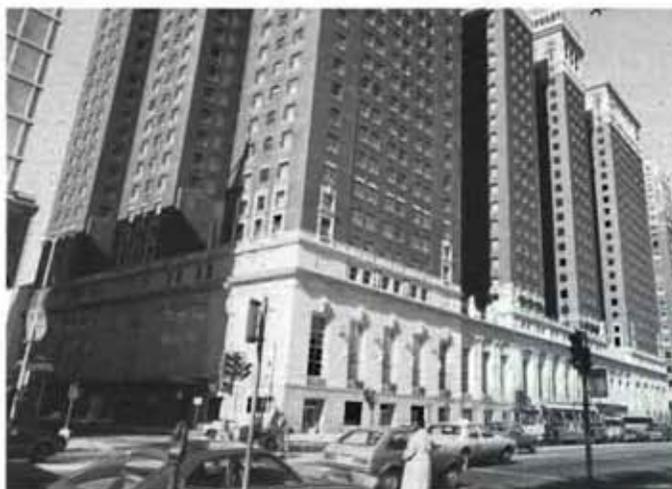
The elegant new 1,620 room Chicago Hilton and Towers after total modernization and addition of parking/fitness center facility (not shown).

No ordinary garage, this one. The 8-story reinforced concrete structure included an enclosed fitness center and large swimming pool with running track on the roof. Below street level was a new exhibition area for the hotel.

Future corrosion problems could not be tolerated for this multi-use parking structure. To guard against future maintenance costs and inconveniences, the designers specified that Grade 60 reinforcing steel be epoxy coated for ramp and deck construction on all seven parking levels. This entailed only a small premium for long-term corrosion protection.

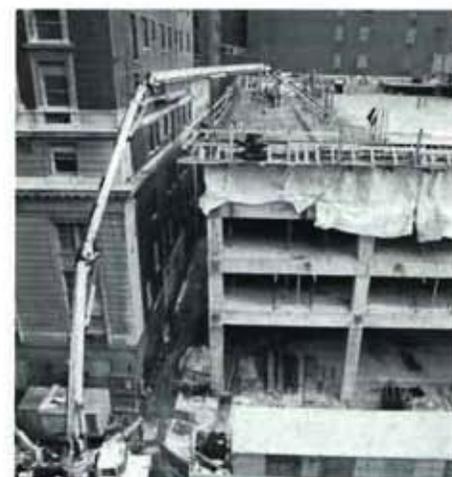
All concrete was pumped for the 8-story garage.

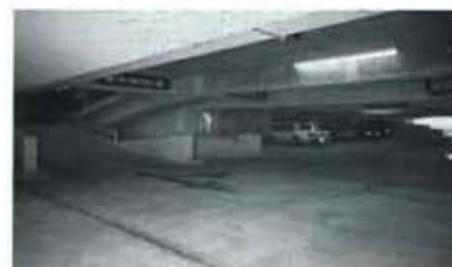
Street level of the garage. Grade 60 epoxy-coated steel was specified for the parking ramps, and decks on all seven of the parking levels.

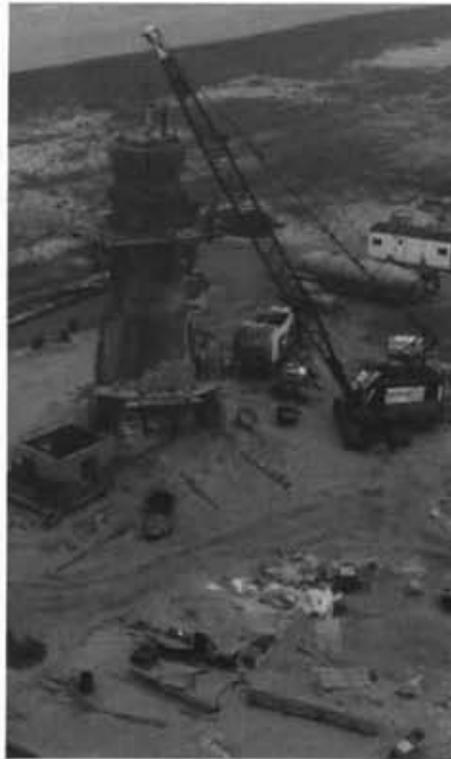
Original cobblestone was replaced around slipformed concrete shaft. All rebar is epoxy-coated.

The new lighthouse is a reinforced concrete structure using the same rubblestone facing of the original tower for much of the new exterior. The lighthouse tower, a 60-foot high hollow shaft, tapers from 24 feet in diameter to 12 feet. The contractor, Hydro-Dredge Corp., New Bedford, Massachusetts cast the tower in four lifts using a climbing formwork system. With salt water close by on one side, brackish water not far underneath and the constant

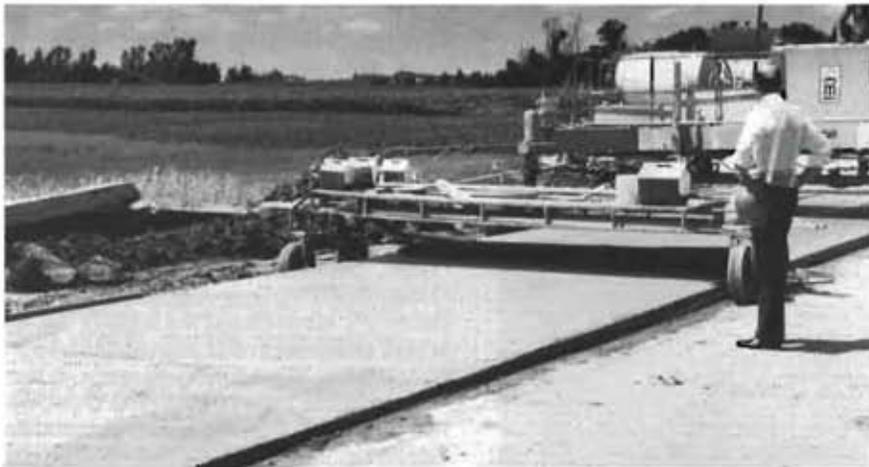
Epoxy-coated rebars are recessed into patched joints of old pavement as load transfers and to prevent later cracking in the concrete overlay.

Before overlaying old, worn pavement with the fast-setting concrete, certain cracks and joints are reinforced with epoxy-coated rebar. This procedure should prevent reflective cracking of the new concrete. Epoxy coating was also used to coat the tie-bars in the widened sections. Epoxy-coating the reinforcing steel protects it from future corrosion which otherwise could lead to concrete spalling and break up.

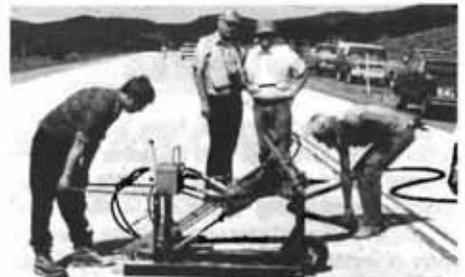
As the diagram and photo show, reinforcing bars are inserted in holes drilled at 35° angles from alternate sides of the crack 30-inches apart. Epoxy is then poured in the holes and rebars inserted. To prevent future corrosion problems at the repaired cracks, the rebar is epoxy-coated.

The Utah Department of Transportation has developed a unique new stitching method of interlocking and tying cracks to prevent separation and also to reinforce cracks.

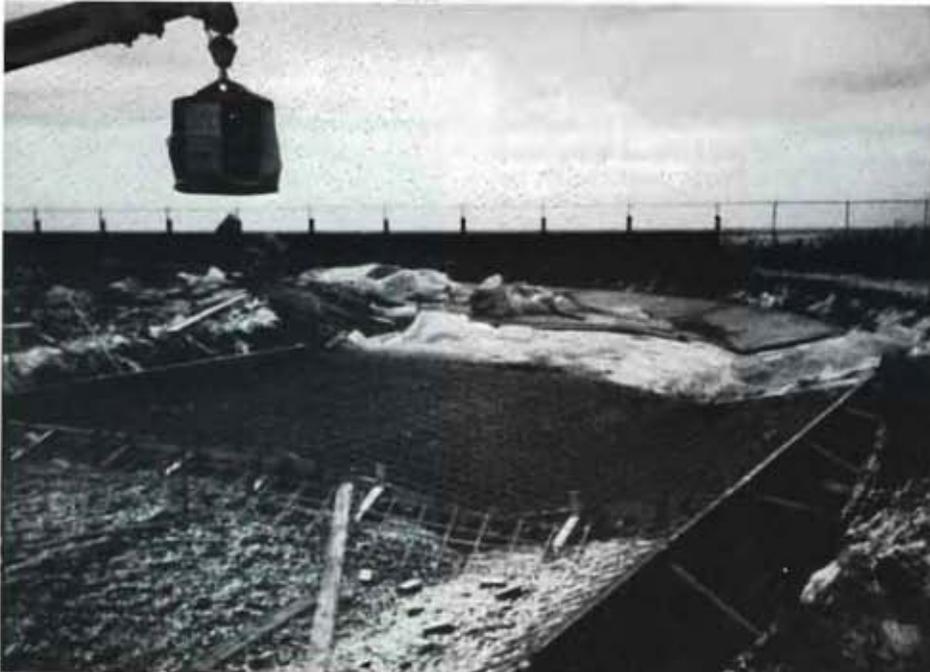
Construction of the large gutter which surrounds the stock pile.

pile area. These concrete "roadways" were built with a dip in the center and pitched to feed runoff water into a large concrete water treatment building. Here, a clarifier separates out coal particles in preparation for final treatment and neutralization before the water is discharged into the lake as pure water.
